F-16 Microbially Influenced Corrosion (MIC) Characterization & Prevention Study

**2011 Environment, Energy
Security & Sustainability
Symposium & Exhibition**

May 12, 2011

**John Stropki
Battelle**

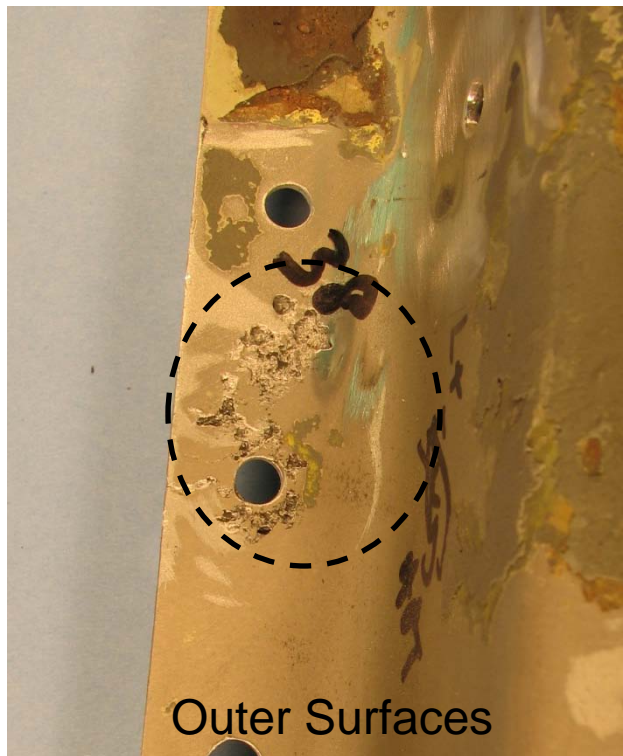
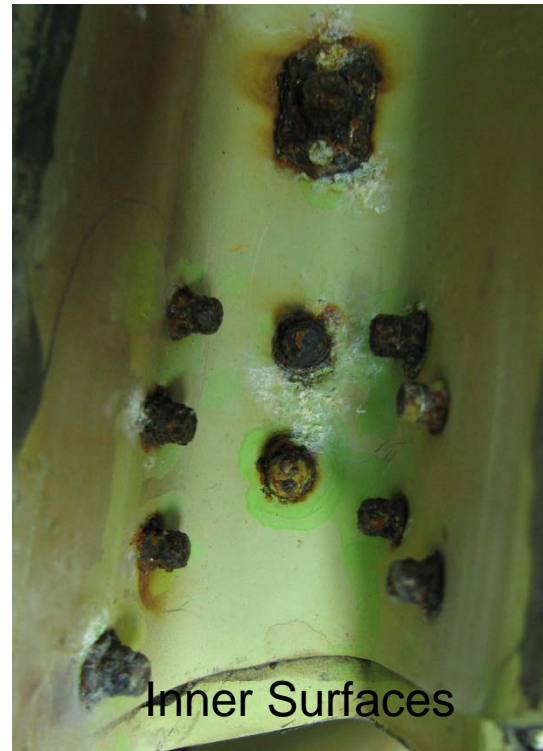
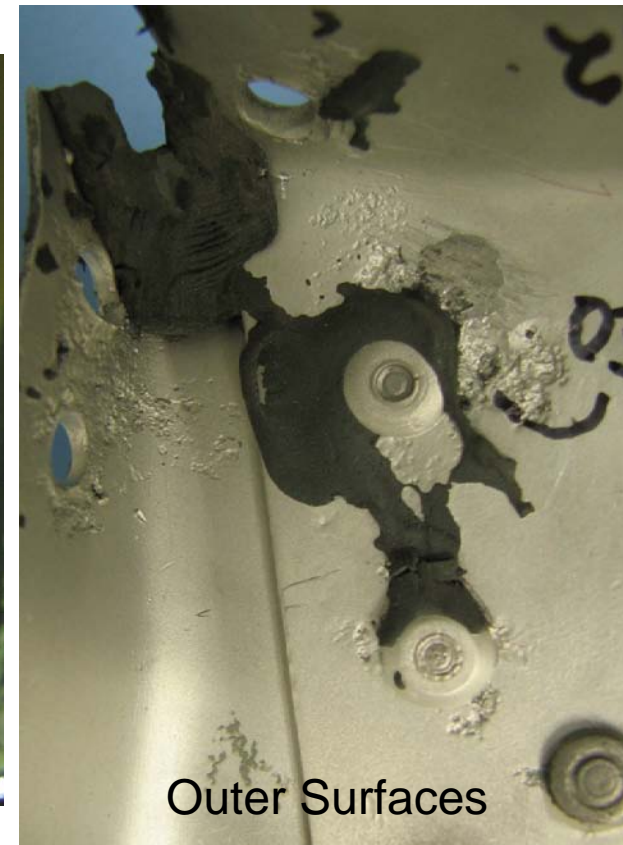
- Most damage confined to pitting corrosion of primary and secondary support structures
- Pitting corrosion morphology (i.e., tunneling suggests MIC)

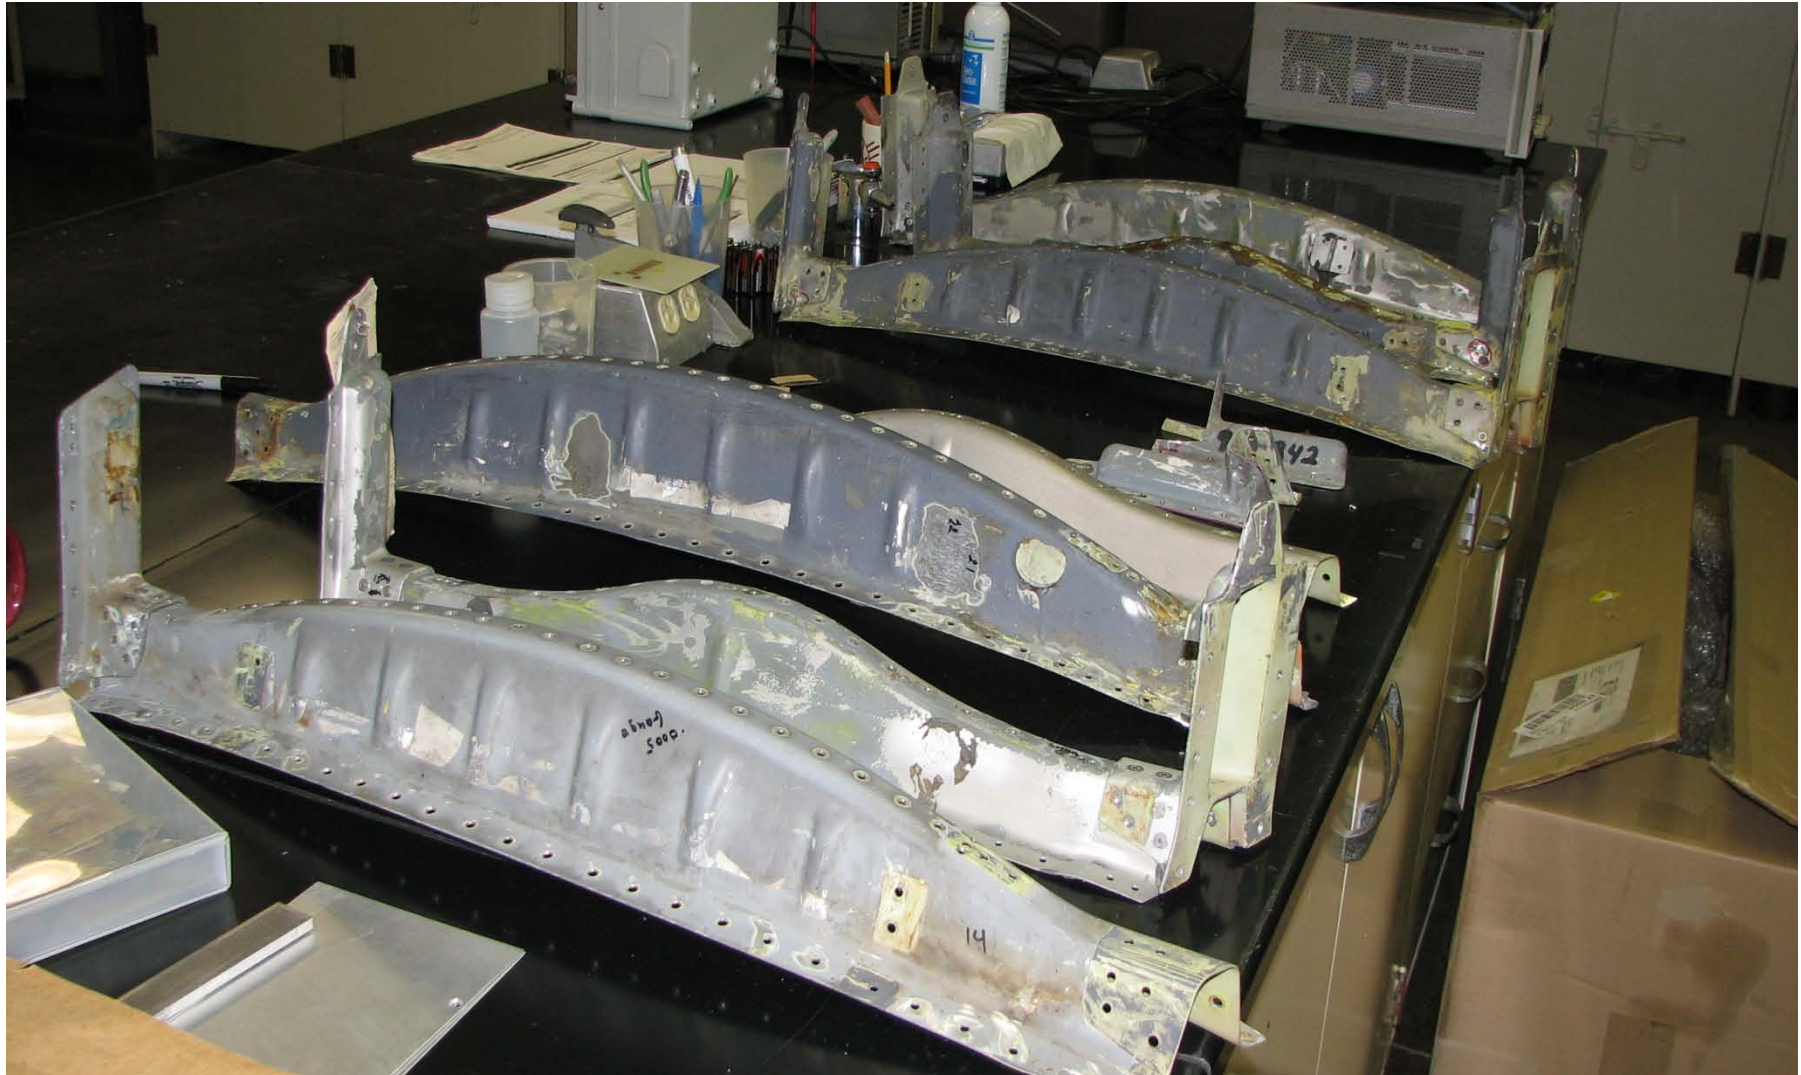
Condemned F-16 Aft Cockpit Component Parts

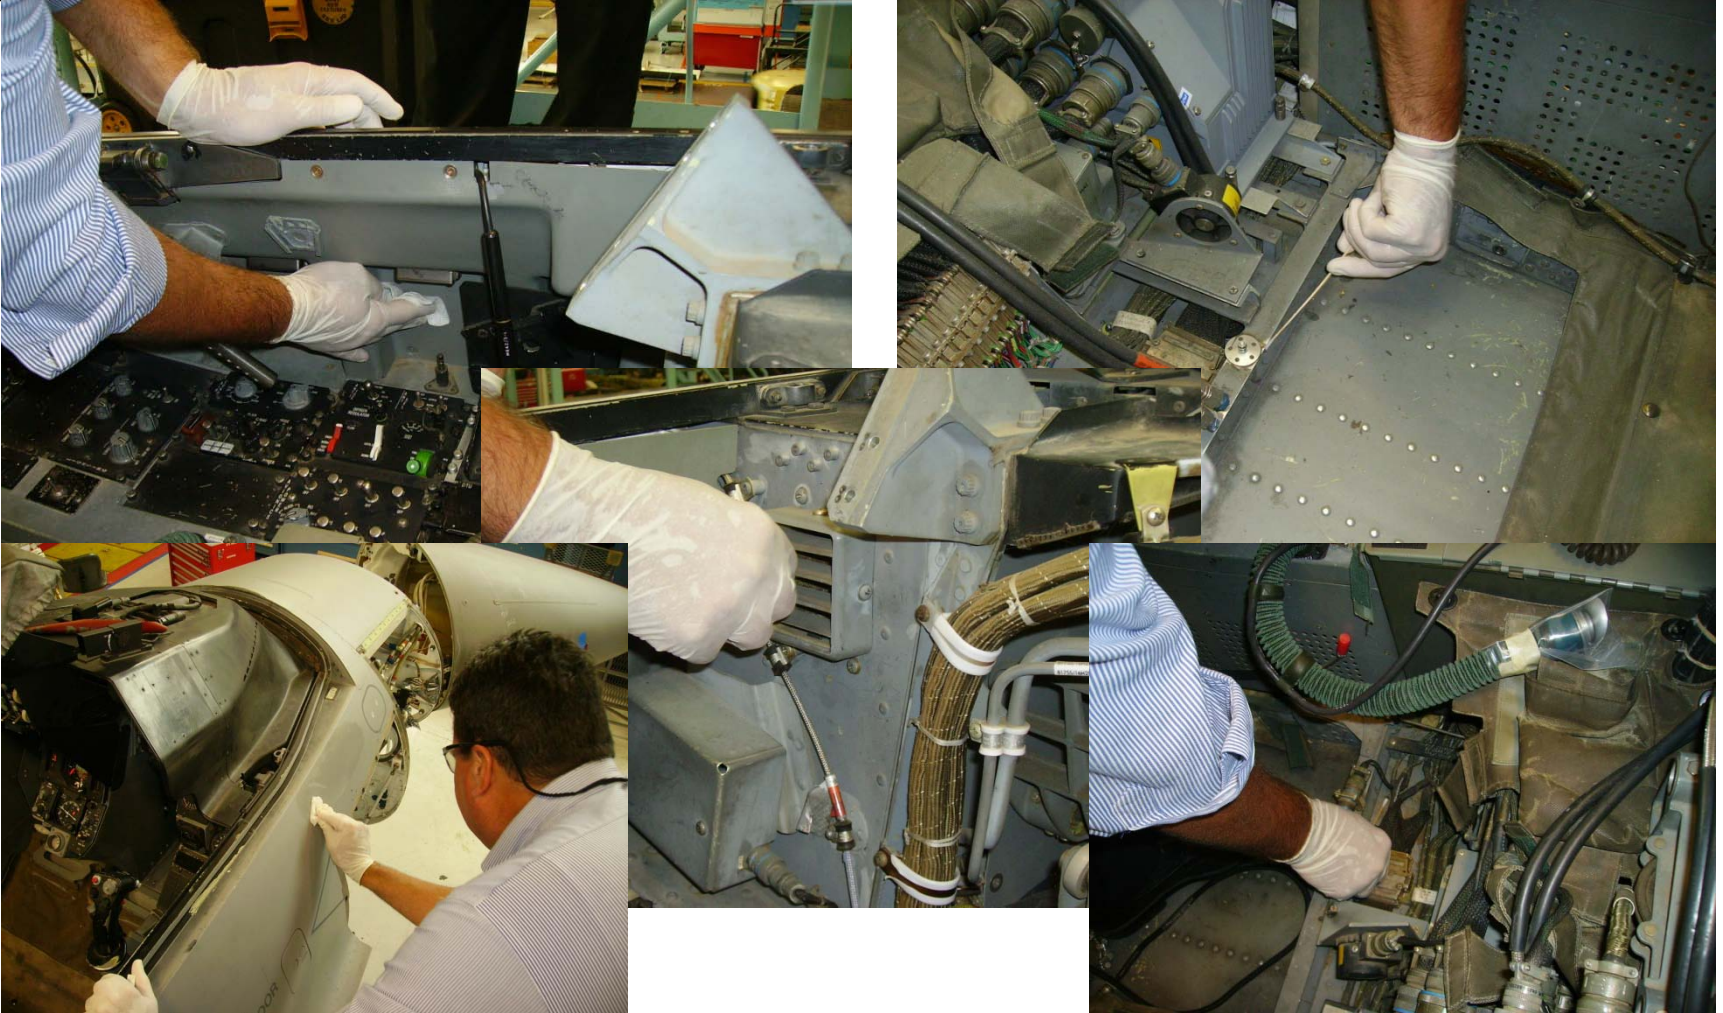
- Sixty-three samples collected from similar cockpit and OML locations (control samples) on six F-16 aircraft at Hill Air Force Base

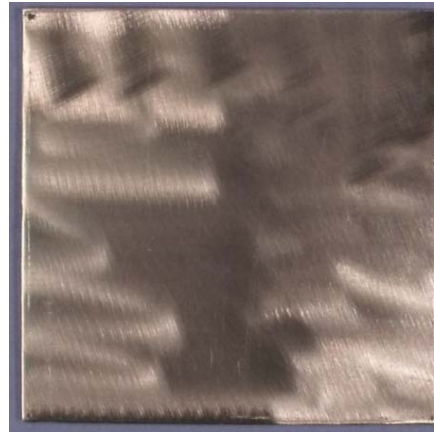
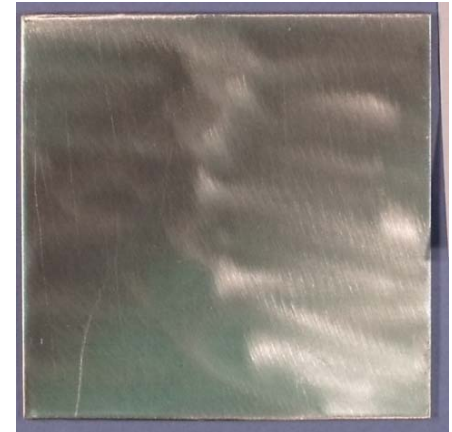
Aluminum Coupon Results: 1-month Exposure, Descaled

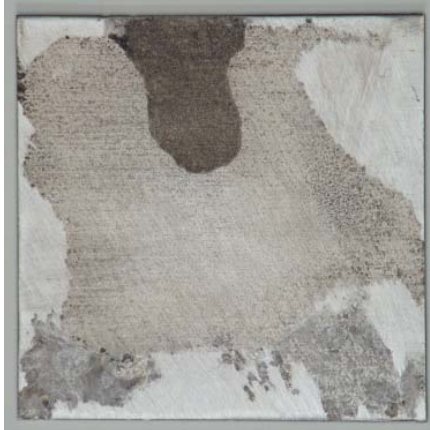
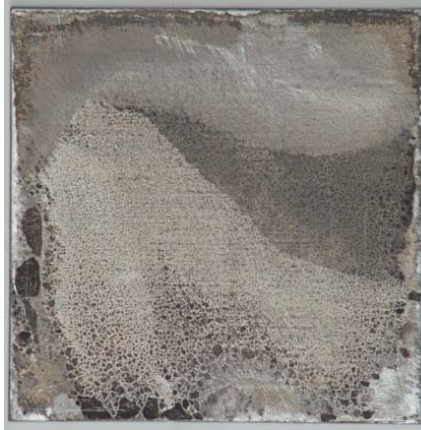
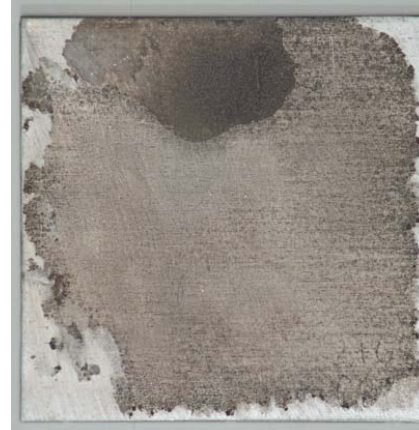
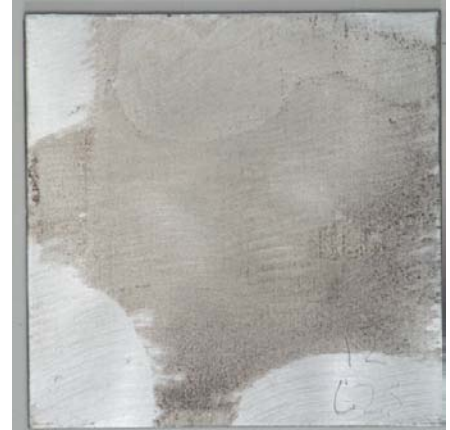
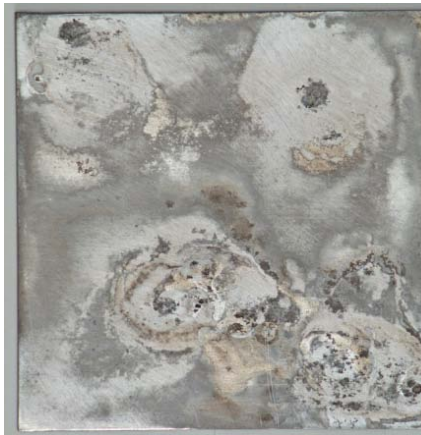
Aluminum Coupon Results: 2-month Exposure, Descaled

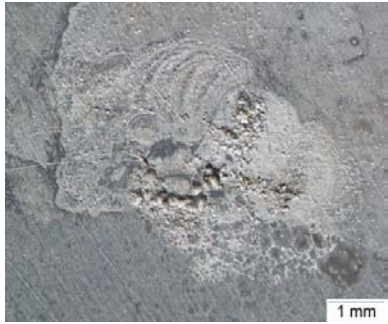
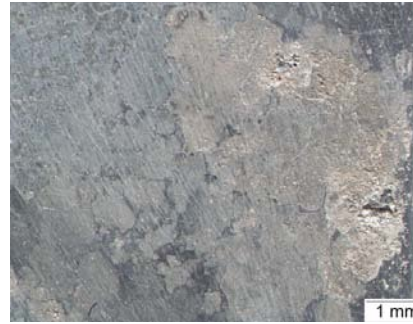
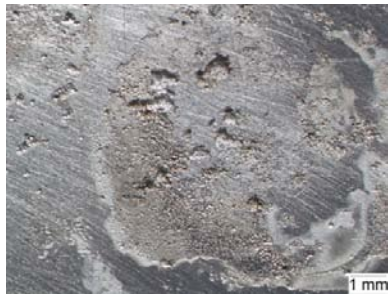
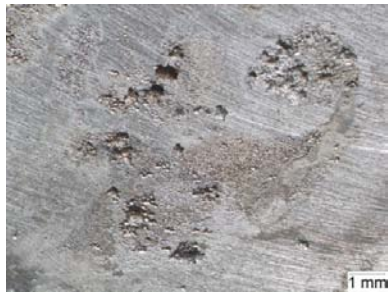
AI Coupon Results: 3 Month Exposure, Descaled - Optical Micrographs

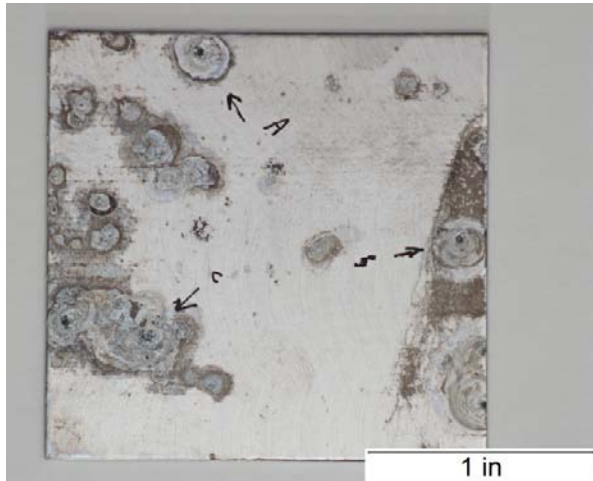
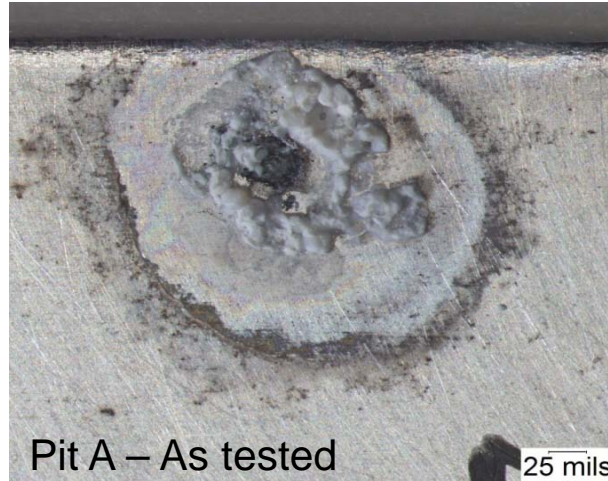
Coupon ID No. 722 (F-16 Consortia)

Aluminum Coupon Results: 3-month Exposure (Representative Sample)

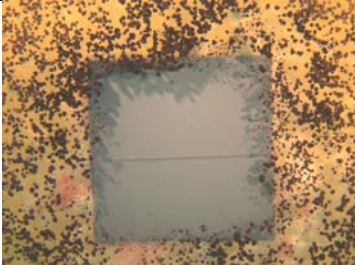
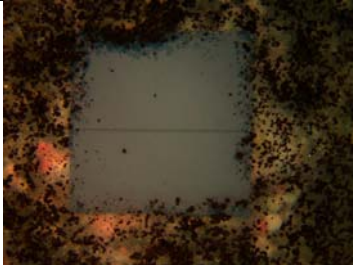
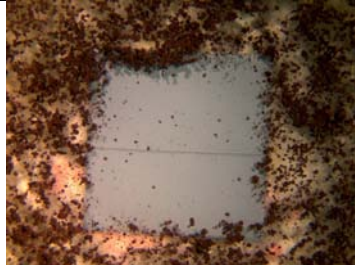
<p>Chrome Conversion Coating + Chrome Primer + Topcoat Coupon Type: C</p> <p><i>Alodine 1200 (Henkel)</i> <i>MIL-PRF-23377H, TY 1, CL 2 (Deft – 02Y040A)</i> <i>MIL-PRF-85285D, TY 4, CL H (Deft – 99GY001)</i></p>

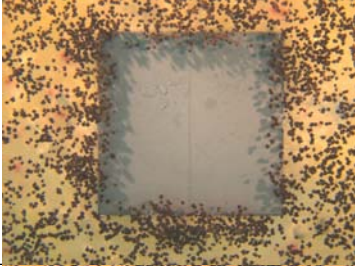
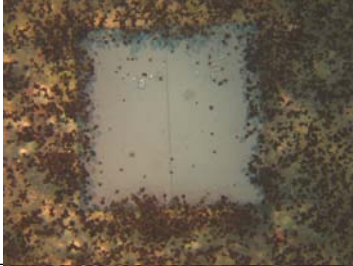
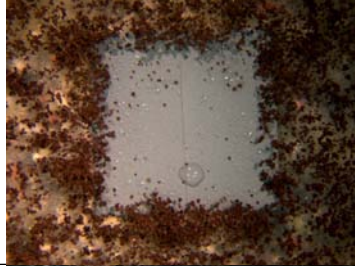
<p>Non-Chrome Treatment + Non-Chrome Primer + Topcoat Coupon Type: G</p> <p><i>Prekote® (Pantheon Chemical)</i> <i>MIL-PRF-23377H, TY 1, CL N (Deft – 02GN083)</i> <i>MIL-PRF-85285D, TY 4, CL H (Deft – 99GN001)</i></p>

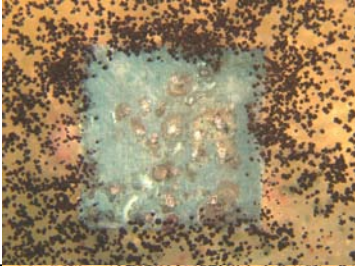
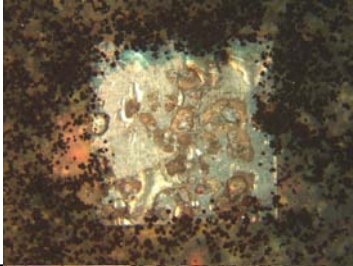
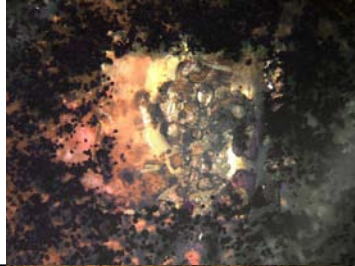
<p>Uncoated Coupon Type: D</p> <p><i>Bare Al2024-T3</i> <i>(Negative Control)</i></p>

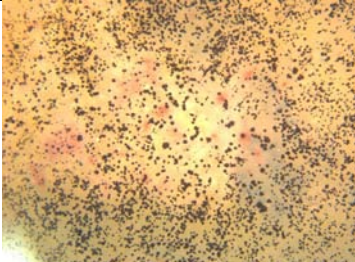
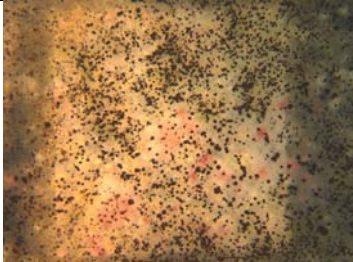
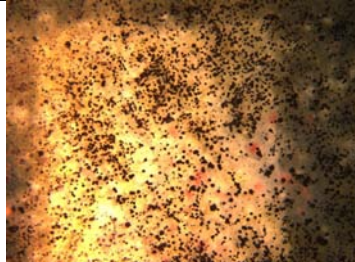
<p>Whatman Paper <i>(Positive Control)</i></p>
